Assignment

Kraatz was contracted by the chartering company, Basil Read, to do repairs to the jib arms of the crane on the NP Glory 4 vessel.

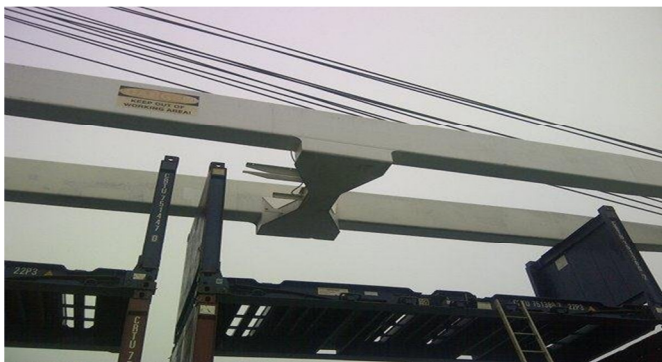
- The damaged area is on the main girder and connecting transvers beam.
- Damaged occurred in a critical section of the jib.
- All repair procedures and welding procedures must be approved by the manufacturer (McGregor) and class (GL).
- Repairs must be done in position.
- Securing the jib section while cropping of the damaged area.
- Preventing distortion during the repairs.
