“O₂ plant Pressure Vessel Repairs”

Assignment

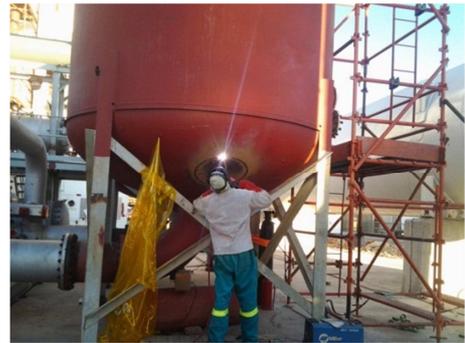
Figure 2: 3G TIG root run in progress

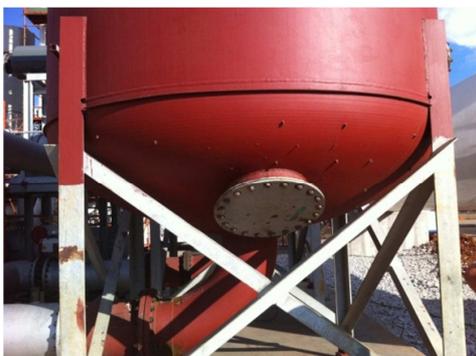
The Pressure vessel was fitted with a manhole for repairs in the USA, but the correct procedures were not followed or documented and subsequently the nozzle was to be cut out and replaced with a patch of the same diameter, material thickness and steel grade.

Figure 1: Pressure vessel before repairs

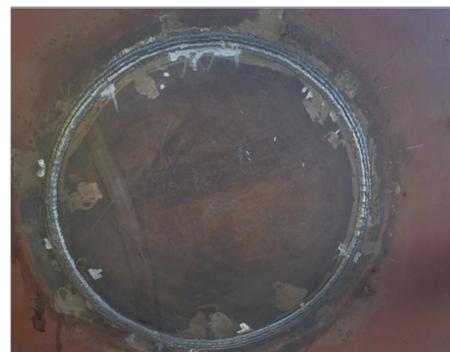
“Thank you for the repair work you guys have completed, the welding of the patch is of a good standard and high quality, the alignment of the patch is acceptable to the codes and we see no problems in the future with this repair.”

Figure 3: Completed insert after 100% X-ray
