Assignment

Kraatz was contacted by Rossing Uranium, a member of the Rio Tinto group, to assist and advise on the reclamation of a thickener gearbox. Sections of the gearbox housing and the associated mechanical lifter mechanism broke due to adverse operating conditions.

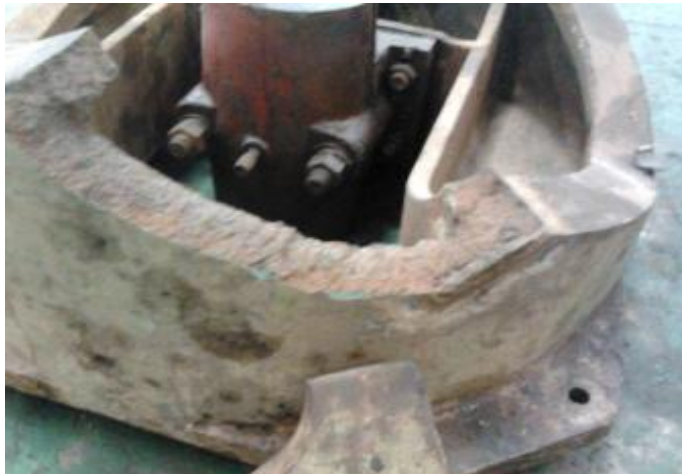
Figure 1 - Broken lifting pedestal

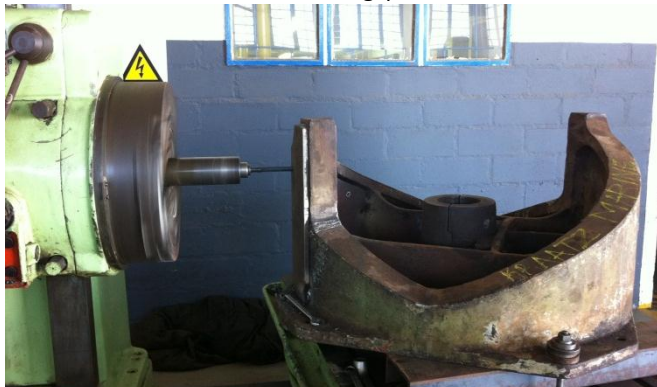
Figure 1 - Drilling of lifting pedestal

Welding cast iron requires special treatment. Once again, attention to the correct weld procedure was critical and therefore preheat and interpass temperatures were closely monitored as well as the cooling process and consumable

selection. Our Line Boring machine was used for machining prior and after welding to adhere to state-of-the-art engineering practices.

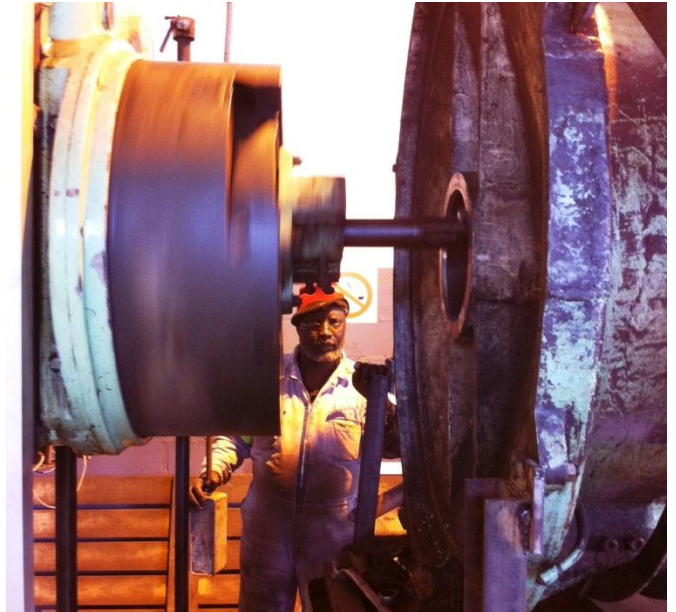
Figure 3 - Machining of gearbox housing

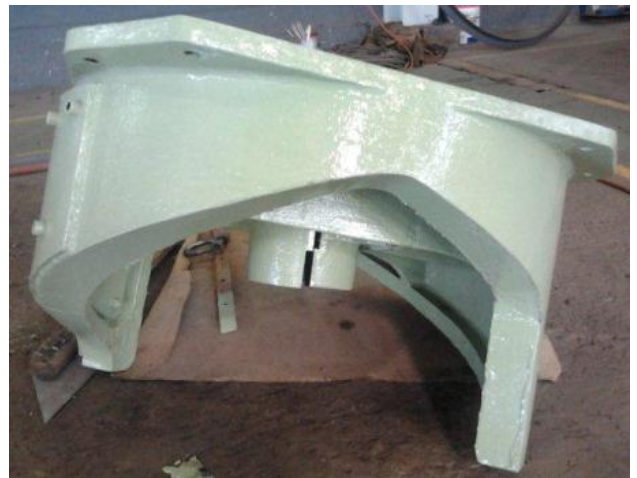
Figure 4 - "Brand new" lifting pedestal
