Assignment

Kraatz was contracted by the Namibian Port authority Namport to refurbish the 2000 ton lifting capacity Syncro lift. The Syncro lift has been in operation from 1972 with no major maintenance to the structure’s or corrosion protection system. A new corrosion protection system was specified with a 15year life expectancy. The scope of work included the steel structure, deck wood and all mechanical components such as gearboxes, winches and sheaves. The total weight of the structure is 400 ton.

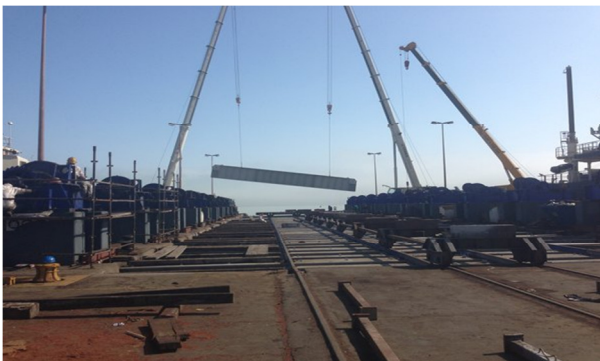
Figure 1 – Removal of platform sections

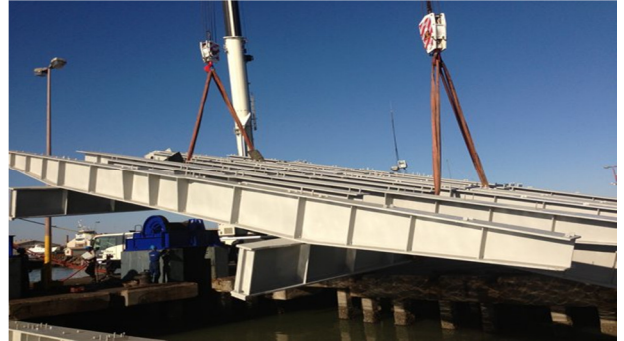
Figure 2 - Fully refurbished section installed

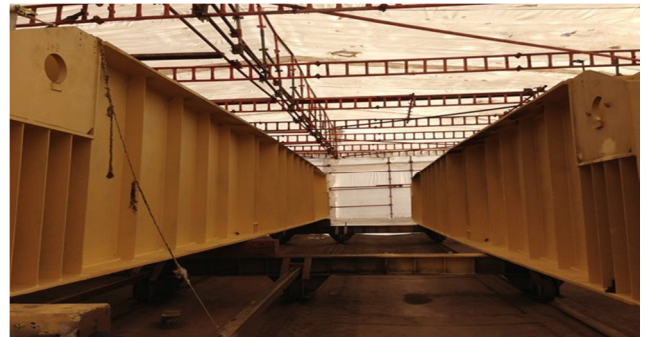
Figure 3 - Corrosion protection in dehumidified enclosures
