Assignment

Kraatz Marine & Offshore was contacted by the vessel “MV Laurika Rickmers” owners appointed agent to assist with the removal of a container that come loose from the spreader and fell in the hold of the vessel.

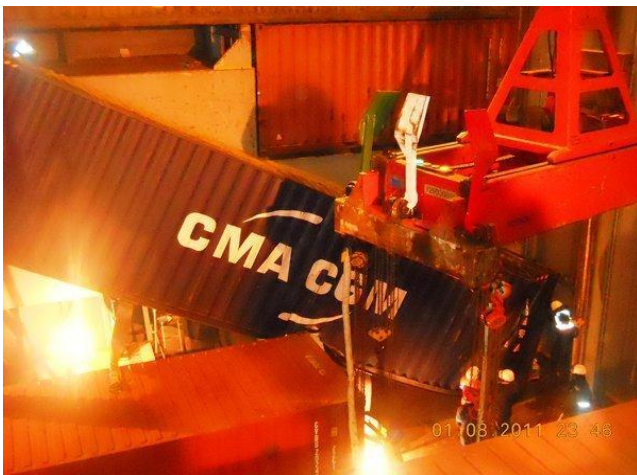
Figure 1 - A tough task

- Position and acute angle of the container.
- Contents of damaged container & other containers.
- Minimizing damage to cell guides and vessel hold.
- Sailing time of vessel

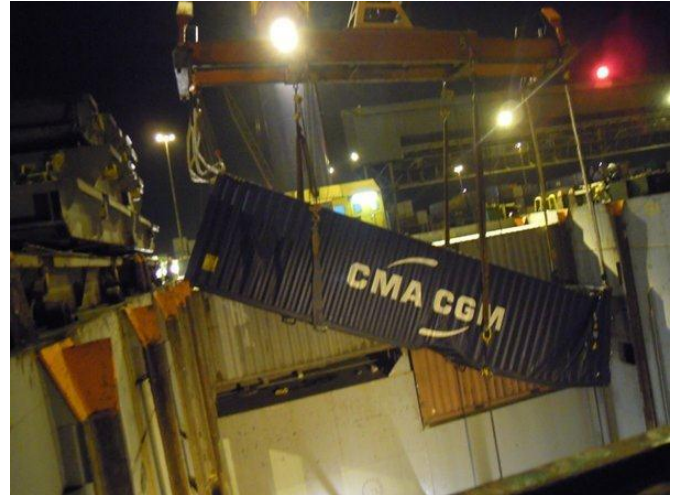
Figure 2 - Work in progress

The container was secured in position to eliminate accidental movement.

Manufacture and fit dogs/hold backs to prevent slippage of slings. Hook up slings and secure to shore side crane and take load on crane.
