Assignment

Kraatz was contracted by the owners of a geo survey vessel to replace wear bars on the keel of a small work boat, as well as fit stiffeners and double plates on the bow to protect the vessel during launching and recovery operations.

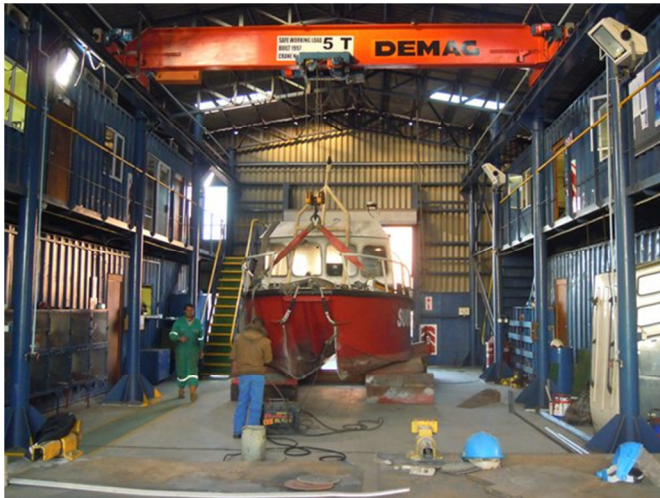
- Removing the work boat from the survey vessel and transport to one of our workshops.
- Improve on the current design (Pipes were previously fitted).
- Removing of damaged wear tubes without damaging the hull plates.
- Minimizing distortion.

After taking all the risks and challenges into consideration, Kraatz proposed to the client to replace the current tubular wear bars with solid round bar.

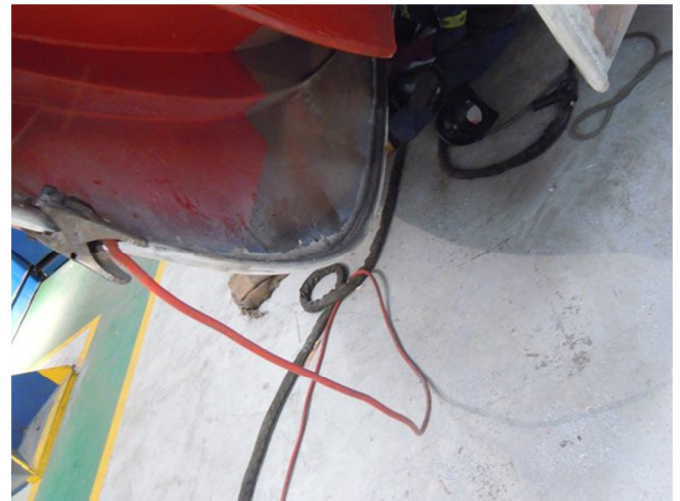
The old damaged wear bars were remove using plasma cutters and new wear bars fabricated using Aluminum round bar.

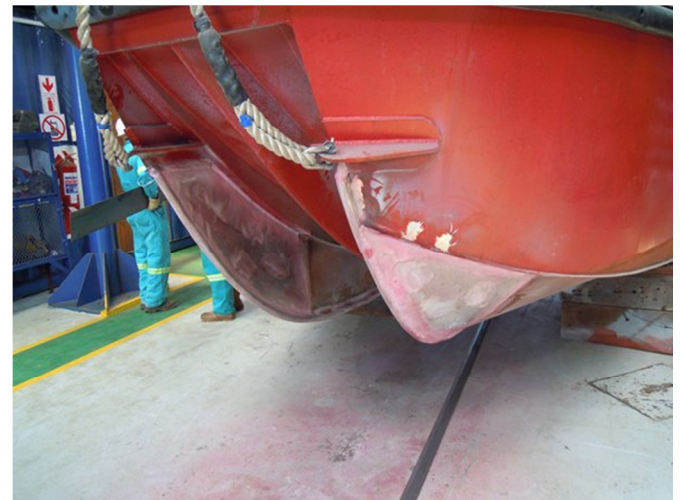
New stiffener/double plates were cut and shaped to fit the inner and outer curve of both hulls. The new improved wear

bars were fitted and all welding completed.

With all welding completed NDE testing was done **Key learning's**
