Assignment

Kraatz was contracted by the chartering company, Basil Read, to do repairs to the jib arms of the crane on the NP Glory 4 vessel.

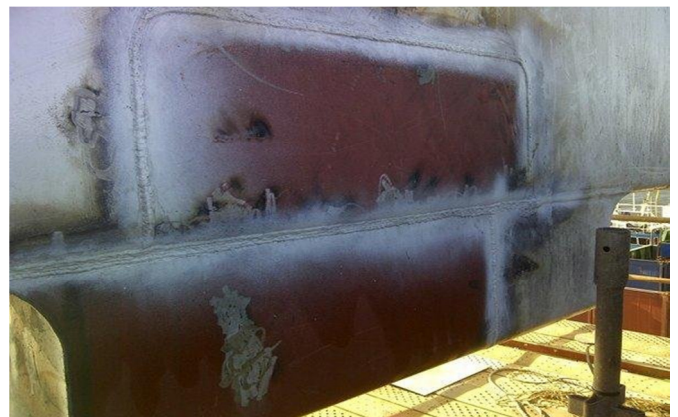
- The damaged area is on the main girder and connecting transvers beam.
- Damaged occurred in a critical section of the jib.
- All repair procedures and welding procedures must be approved by the manufacturer (McGregor) and class (GL).
- Repairs must be done in position.
- Securing the jib section while cropping of the damaged area.
- Preventing distortion during the repairs.

Backing strips and new insert sections were fitted as per procedure. All welding was done as per procedure while continuously monitoring jib section for any signs of heat distortion.

On completion of all welding MPI were carried out and crane was load tested and certified as safe for use.

Once the load test was completed all documents were submitted to the client, crane manufactures and class for approval and acceptance.
