## Assignment

Kraatz was contracted by Rosh Pinah Zinc to refurbish an Osborne jaw crusher. Traditionally the client sent these type of engineering assignments to South Africa. This requires the piece of equipment be exported temporarily, refurbished and then later imported again which has a negative cash flow impact on the client. Kraatz approached the Namibian Osborne sales agent who provided full back-up support.

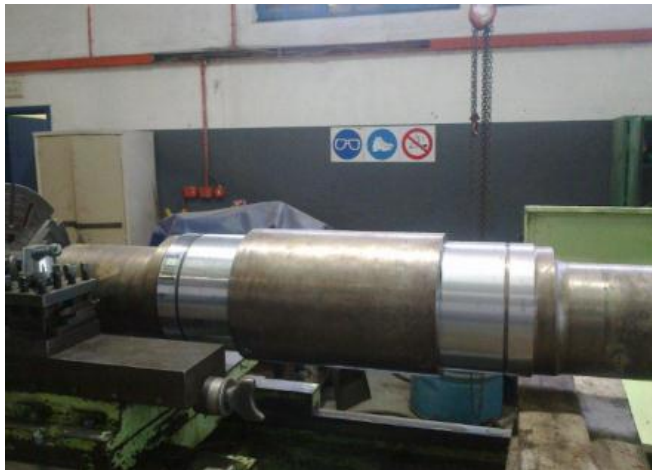
**Figure 1 - Machining of Shaft**

As soon as the jaw crusher arrived at Kraatz’s workshop it was stripped for inspection and a detailed report was prepared for the client. Subsequently the scope was defined and Kraatz started machining the worn shaft. Welding repairs followed before final machining was done.

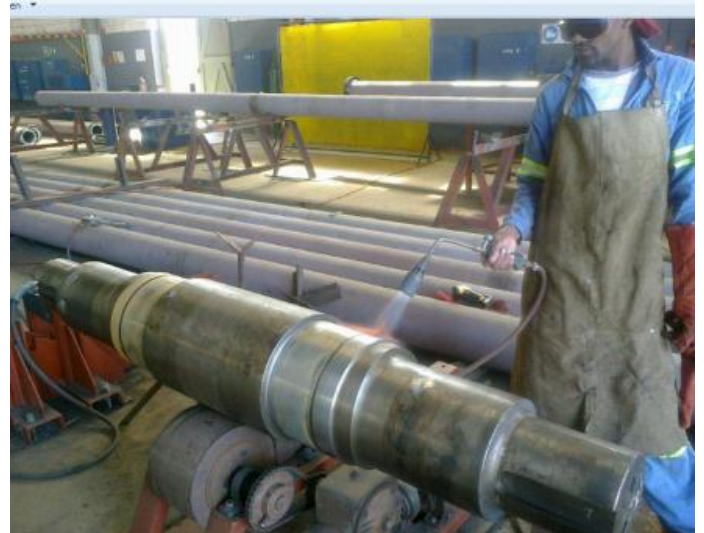
**Figure 2 - Equal Soak preheating on Rotator**

Attention to the correct weld procedure was critical and therefor preheat and interpass temperatures were closely monitored as well as the cooling process and consumable selection. New Bearings were fitted and the structural integrity was improved by crack repairs.

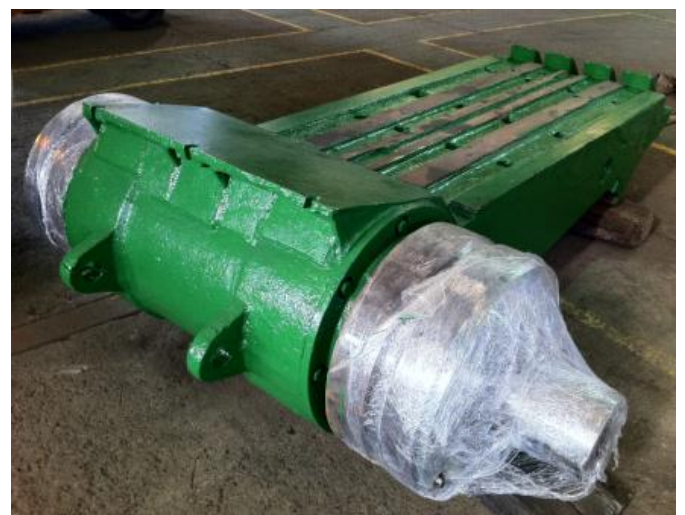
**Figure 3 - Ready for shipment and installation**
